## SR 211 From Stockton St. to Osceola St. - Pavement Distress

**Project Owner:** FL. Dept. of Transportation

### **Project Profile:**

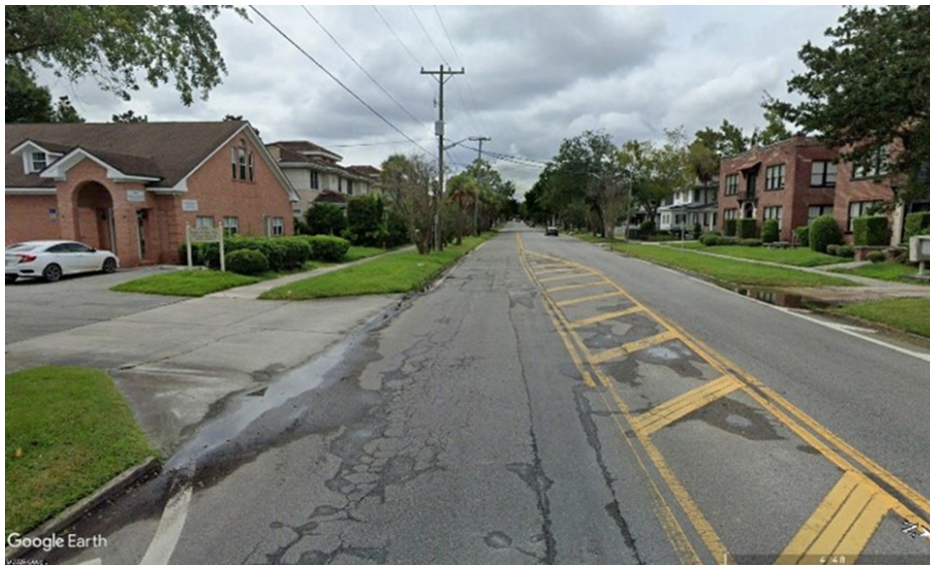
The pavement distress is located within the eastbound travel lane of SR 211 beginning from approximately 160 feet east of the SR 211 and Stockton Street intersection and extending approximately 600 feet east towards the SR 211 and Osceola Street intersection in Jacksonville, Duval County, Florida. This task order included performing a geotechnical exploration and engineering analysis to assist the design team in conducting site reconnaissance to observe existing site conditions and analyzing and interpreting data for reporting. We performed six auger borings to evaluate the subsurface conditions within the pavement distress area. Soil samples recovered during performance of the borings were delivered to the lab and visually described by a geotechnical engineer.
